#### AUTOMATED 3D BREAST ULTRASOUND (ABUS) FOR BREAST CANCER SCREENING

#### OUTLINE:

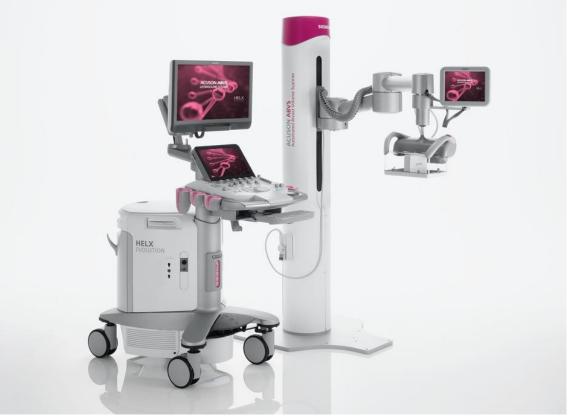
According to the <u>European Journal of Radiology</u>, adding 3D ABUS to mammography screening in dense breasts increases cancer detection without increasing the radiation dose and with an acceptable recall rate.

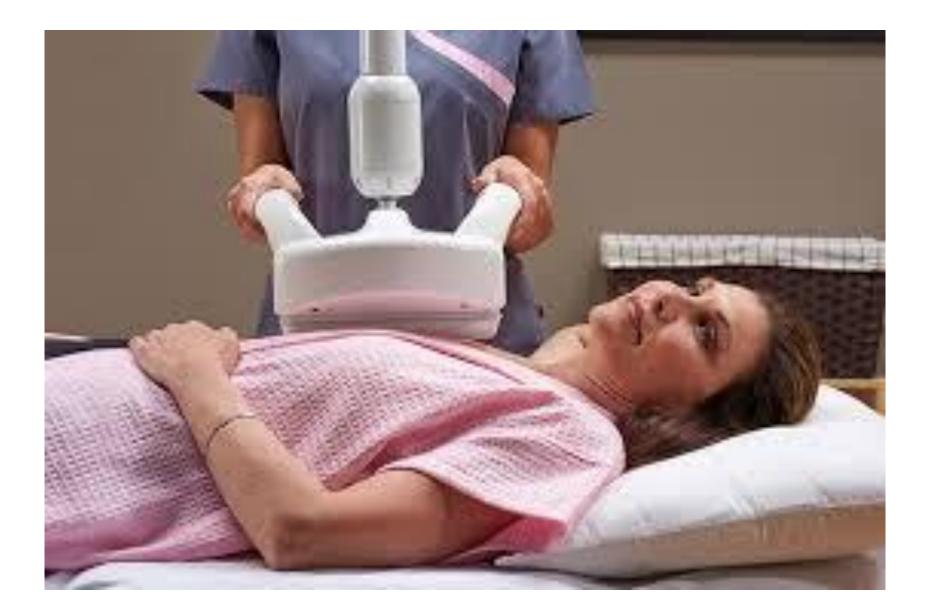
- To obtain good-quality images, abundant use of water-based gels or lotion on the skin of the breast is mandatory.
- This prevents poor contact between the transducer and the skin and allows the ultrasonic wave to pass into the breast.
- The acquisition depth of the transducer is adjustable to up to 6 cm, depending on breast size.
- We can adjust the time-gain function and focus region of the transducer to improve the image quality.
